PLAVECKY CASTLE

A brief guide to the castle ruins

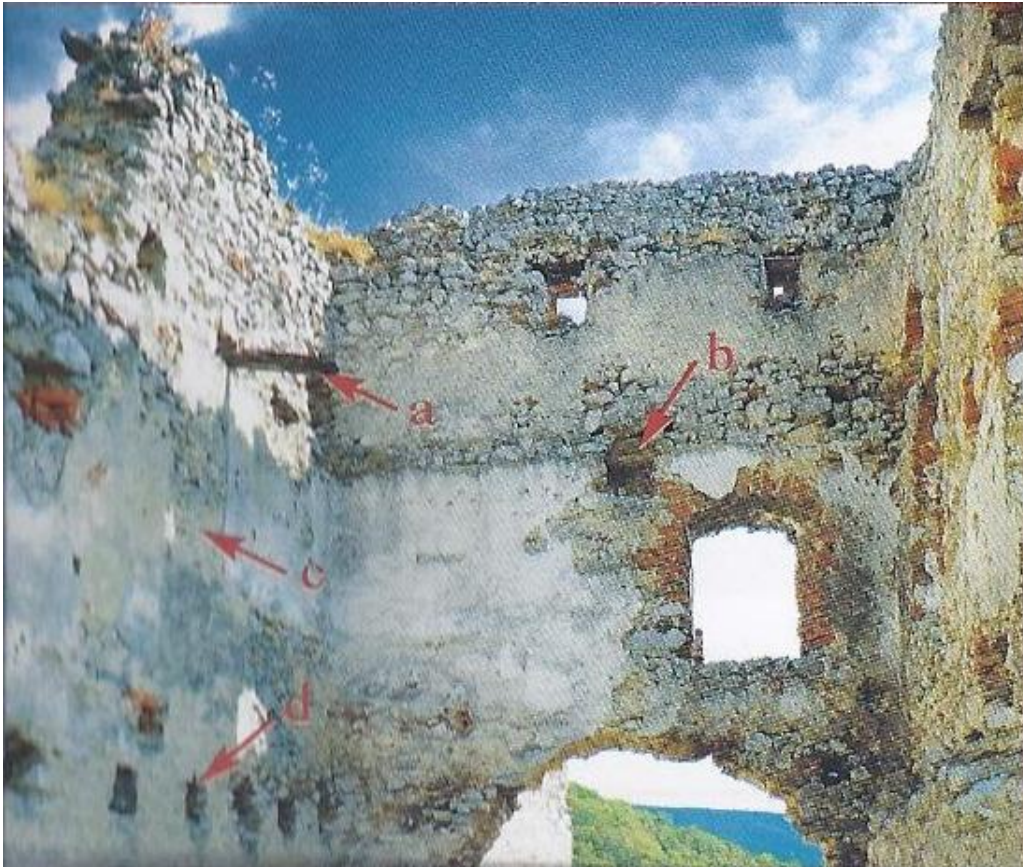
Picture 1 - room above the gateway of the entry gate tower, a – remains of the beam ceiling of the 2nd story, b – beam supporting the walling, c – furnace, d – seats remaining after beams of the original 1st story ceiling.

The ante-gate leads to the three-story entry gate tower (4), which originally had a guard station above the gateway as well as a further defense story with a shooting position. On the internal walls of the tower gate, even today, the remains of the beam ceiling can be seen, and on the right (eastern) wall of the second story, we can see plaster with the imprint of a former furnace heating the guard station (Picture 1).

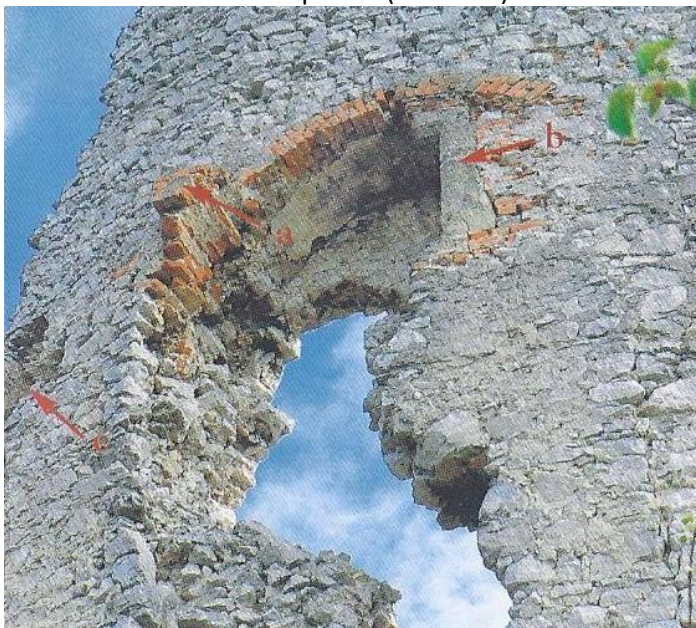
Picture 3 -Northern wall of the castle palace, a – remains of the prevét, b – remains of the palace gothic window, c – crenel of the walled in battlement of the original wall

Behind the building, the yard is lined by the remains of a turret on the left side (5) with a uniquely preserved shooting position. At the end of the yard, we can enter a rocky plain, where the wall of the originally enclosed the area of the castle outwork. To the right side above us, the best preserved wall of the castle palace stands (22), containing the remains of a gothic window, later walled in and used for the construction of a prevét (Picture 3).

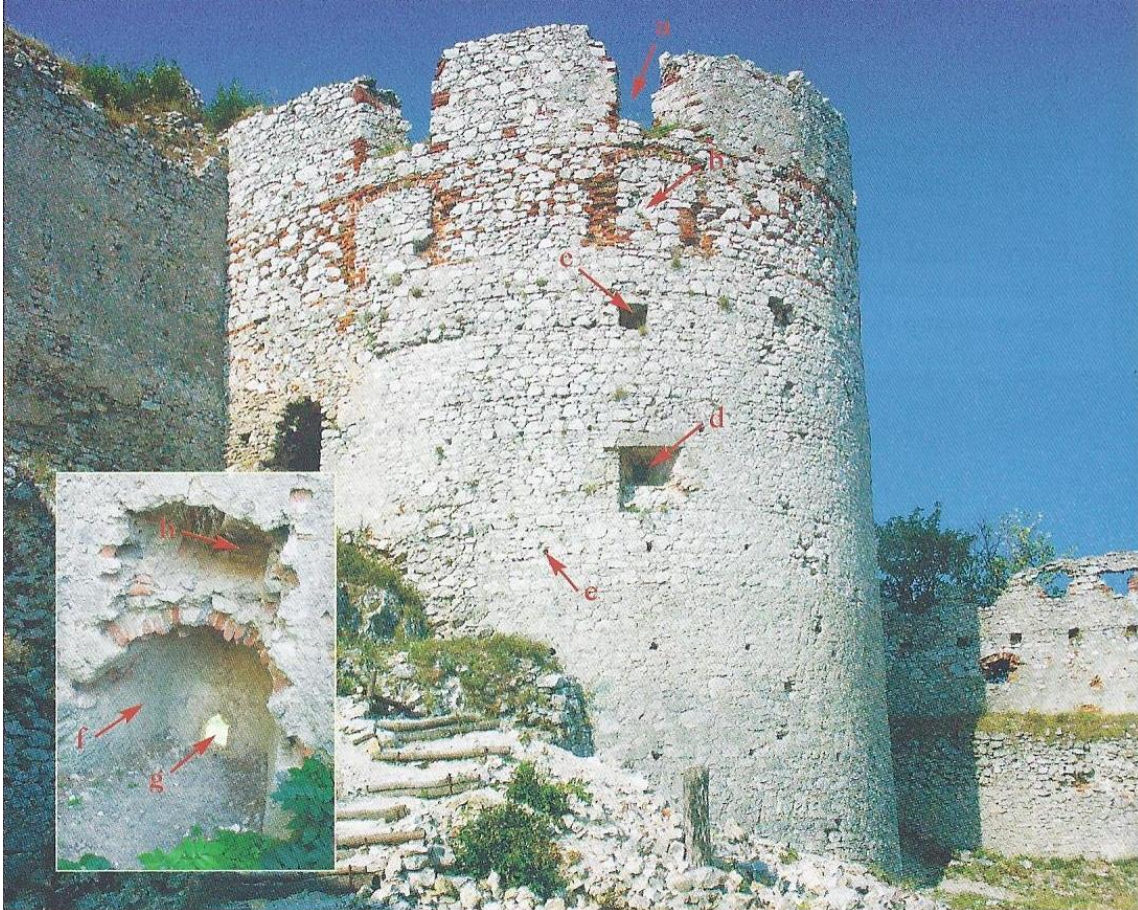
Picture 6 - cannon turret of the upper castle, a – shooting position, b – walled in shooting position, c – ventilation channel, d – cannon shooting position, e – opening left behind after wooden scaffolding, f – chamber shooting position for cannon, g – shooting position opening, h – ventilation channel

The cannon shooting positions with a straight stone cap widening outwards are placed approximately half way up on the turret and aim at the saddleback to the south of the castle, where possible danger of attack lurked. Above the left (south western) shooting position, we can see an opening in the wall, used to ventilate the smoke created by cannon fire. Above it, we see two additional lines of cannon shooting positions; the lower ones have been walled in, though (Picture 6).

From the yard, we ascend along a restored stairway passing through the remains of the defense wall supporting the fortification of the face of the upper castle (12) and enter the interior of the cannon turret (18). As opposed to the rounded external shell, the interior space is pentagonal. After entering the turret, on the right side, we see a shooting position with a chamber for the cannon, above which is a ventilation channel evacuating the firing smoke outside of the turret (Picture 6).

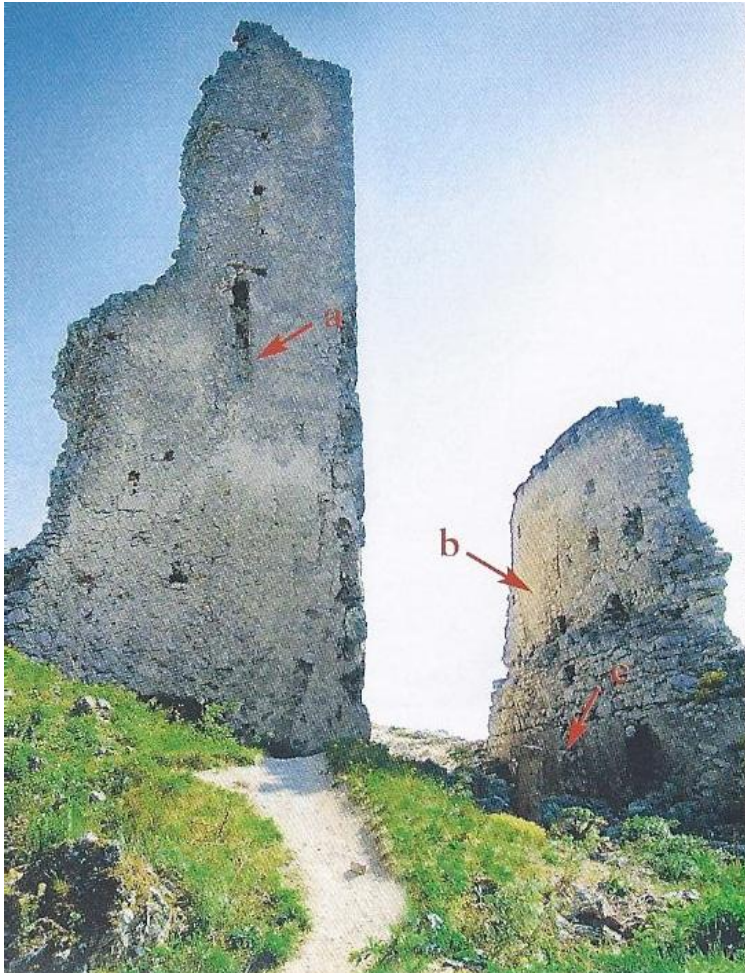
Picture 7 – housing tower and a part of the walls of the upper castle, a – seat of the bearing beam to support the wooden walkway for entering the tower, b – wall extension, c – walled in battlement crenels of the southern wall.

Upon entering the upper castle on the right side, there is a short round turret protruding from the walling (17), the shooting positions of which protected the area of the eastern side of the castle. An important part of the yard is the remains of a massive housing tower (19), preserved up to the five original stories. The lower part of the tower is currently almost completely filled with the caved in walls, but in the higher up parts, we can still see the remains of windows of the housing rooms looking out to the west, onto the Záhorská valley. The northern façade of the tower contains artifacts of beams that remain from the staircase support or the walkway leading to the high up entry (Picture 7).

It is possible to descend the tower into the cellar with partially preserved arches (20), which is situated in the narrow space between the tower and the southern wall (15). We continue with our tour via a narrow passage between the tower and the western wall (16), where just above ground level, we can see the walled in original battlement crenels (Picture 7).

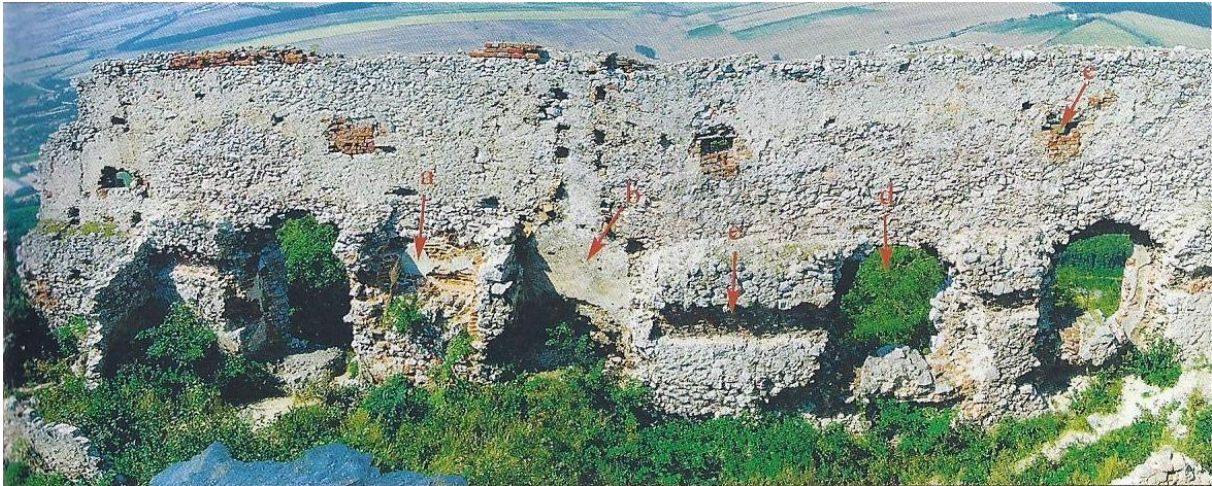
Picture 8 – housing building of the upper castle, a – walled in alcove, b – furnace with chimney, c – remains of arches of the 2nd story, d – windows of the 2nd story, e – windows of the 3rd story

The path passes directly through its interior and today, hardly anyone will notice that they are walking on the arches of the caved in lower story. The second story contained brick arches and in its interior in the north, there was a hall with windows facing west. The central part of the wall contains a walled in alcove and beside it, the remains of a furnace and chimney. The building had three stories and according to the ventilation windows apparent in the wall, we can assume that the third story was hardly lighted (Picture 8).

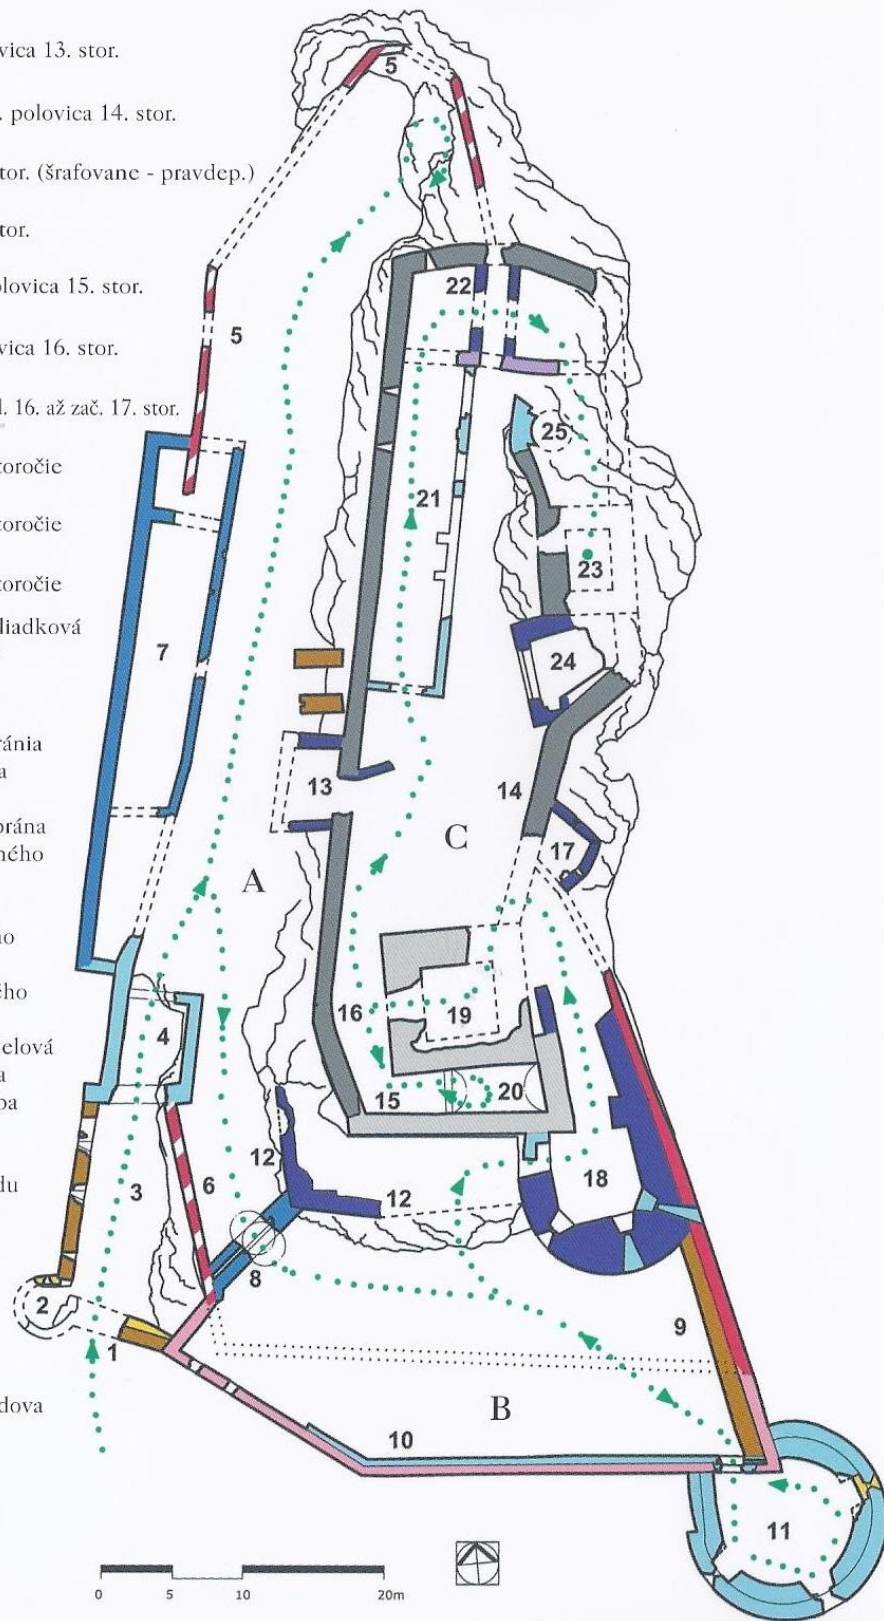
Legend

I	mid 13 th century
II	approx. 1 st half of the 14 century
III	14 th century (hatched – presumed)
IV	15 th century
V	second half of the 15 th century
VI	mid 16 th century
VII	second half of the 16 th century until early 17 th century
VIII	17 th century
IX	17 th century
X	17 th century

1. Ante-gate gate
2. Ante-gate turret
3. Ante-gate
4. Castle tower gate
- 5., 6. Western castle outwork walls
7. Housing building
8. Gate to the southern castle outwork
- 9., 10. Southern castle outwork walls
11. South eastern castle outwork cannon turret
12. Defensive wall of the upper castle
13. Upper castle entry gate
- 14., 15., 16. Upper castle walls
17. Upper castle eastern turret
18. Upper castle cannon turret
19. Housing tower
20. Agricultural structure
21. Housing building
22. Castle palace
23. Tower
24. Tower extension
25. Cistern

The original establishers of the castle, the Detrichs, who build the castle in the 13th century (ground plan – I) can be attributed with the construction of the castle with battlement (14, 16), surrounding the edge of the rocky hilltop and the rectangular guard tower (23) on the top of the rock. This simple form of the original fort was probably completed by a housing building at the north-western corner the appearance of which we do not know today, as its remains have been covered by newer constructions. Later, perhaps in the beginning of the 14 century, the most vulnerable eastern face of the castle was strengthened and it received a dominating feature in form of a rectangular housing tower (19). To it, new fortification was attached, extending the castle area (15) with a gate at the eastern side the tower protected (ground plan – II).

Later in the 14th century and during the reign of the Stibor family and their heirs, the counts of st. Jur and Pezinok, the original castle grew substantially. Better fortification of the castle was achieved by an extensive castle outwork (ground plan – III), placed along the southern and western foothill of the castle rock (5, 6, 9), which also provided sufficient space for agricultural buildings necessary for life of the fortified castle. In the upper castle, the confined housing space of the towers was increased by a four-story palace (22) on the best-protected edge of the rock (ground plan – IV).

The extensive area of fortification of the outwork was, by the end of the Middle Ages, increased even more by moving the southern wall (ground plan – V). In its south-eastern corner, apparently an entry gate was created. Today, only the portal remains, which allows access to the corner cannon turret. The newly-constructed fortification (10) contained battlements with shooting positions in the crenels.

In the middle of the 16th century, in connection with the growing threat of Turkish invasions, it became necessary to strengthen the fortification, which led to the construction of a new horse shoe shaped turret with chambered cannon shooting positions in the corner of the upper castle (18)

In the course of the 16th century, gradual improvement of the fortification took place, including an expansion of the housing and agricultural premises. Thus, the large transversal fortification wall with gate was created (8), which divided the originally single space of the castle outwork into two separate parts, as well as a large housing building (7), used by the inhabitants of the lower castle (Ground plan – VII).

The final construction modifications made by the Pálffy family at the upper castle took predominantly the form of finishing buildings along the whole length of the western wall (21) and extending the housing tower (19). At the lower castle, they modernized the fortification by extending the walls and placing new walkways with shooting positions. The most recent modifications include the construction of another cannon turret (11, Ground Plan – VIII). It as well as its older turret apparently blocked the original gate and forced the castle entrance to be relocated. The newly-erected entrance was moved to the south-western part of the area. It was protected by a tower gate (4), later supplemented by an extended ante-gate with turret (1, 2, 3, ground plan – IX).
